AMERICAN AIRLINES, INC.  
BOEING 727, N1996  
NEAR THE GREATER CINCINNATI AIRPORT  
CONSTANCE, KENTUCKY  
NOVEMBER 8, 1965

## AIRCRAFT ACCIDENT REPORT

ADOPTED: September 28, 1966

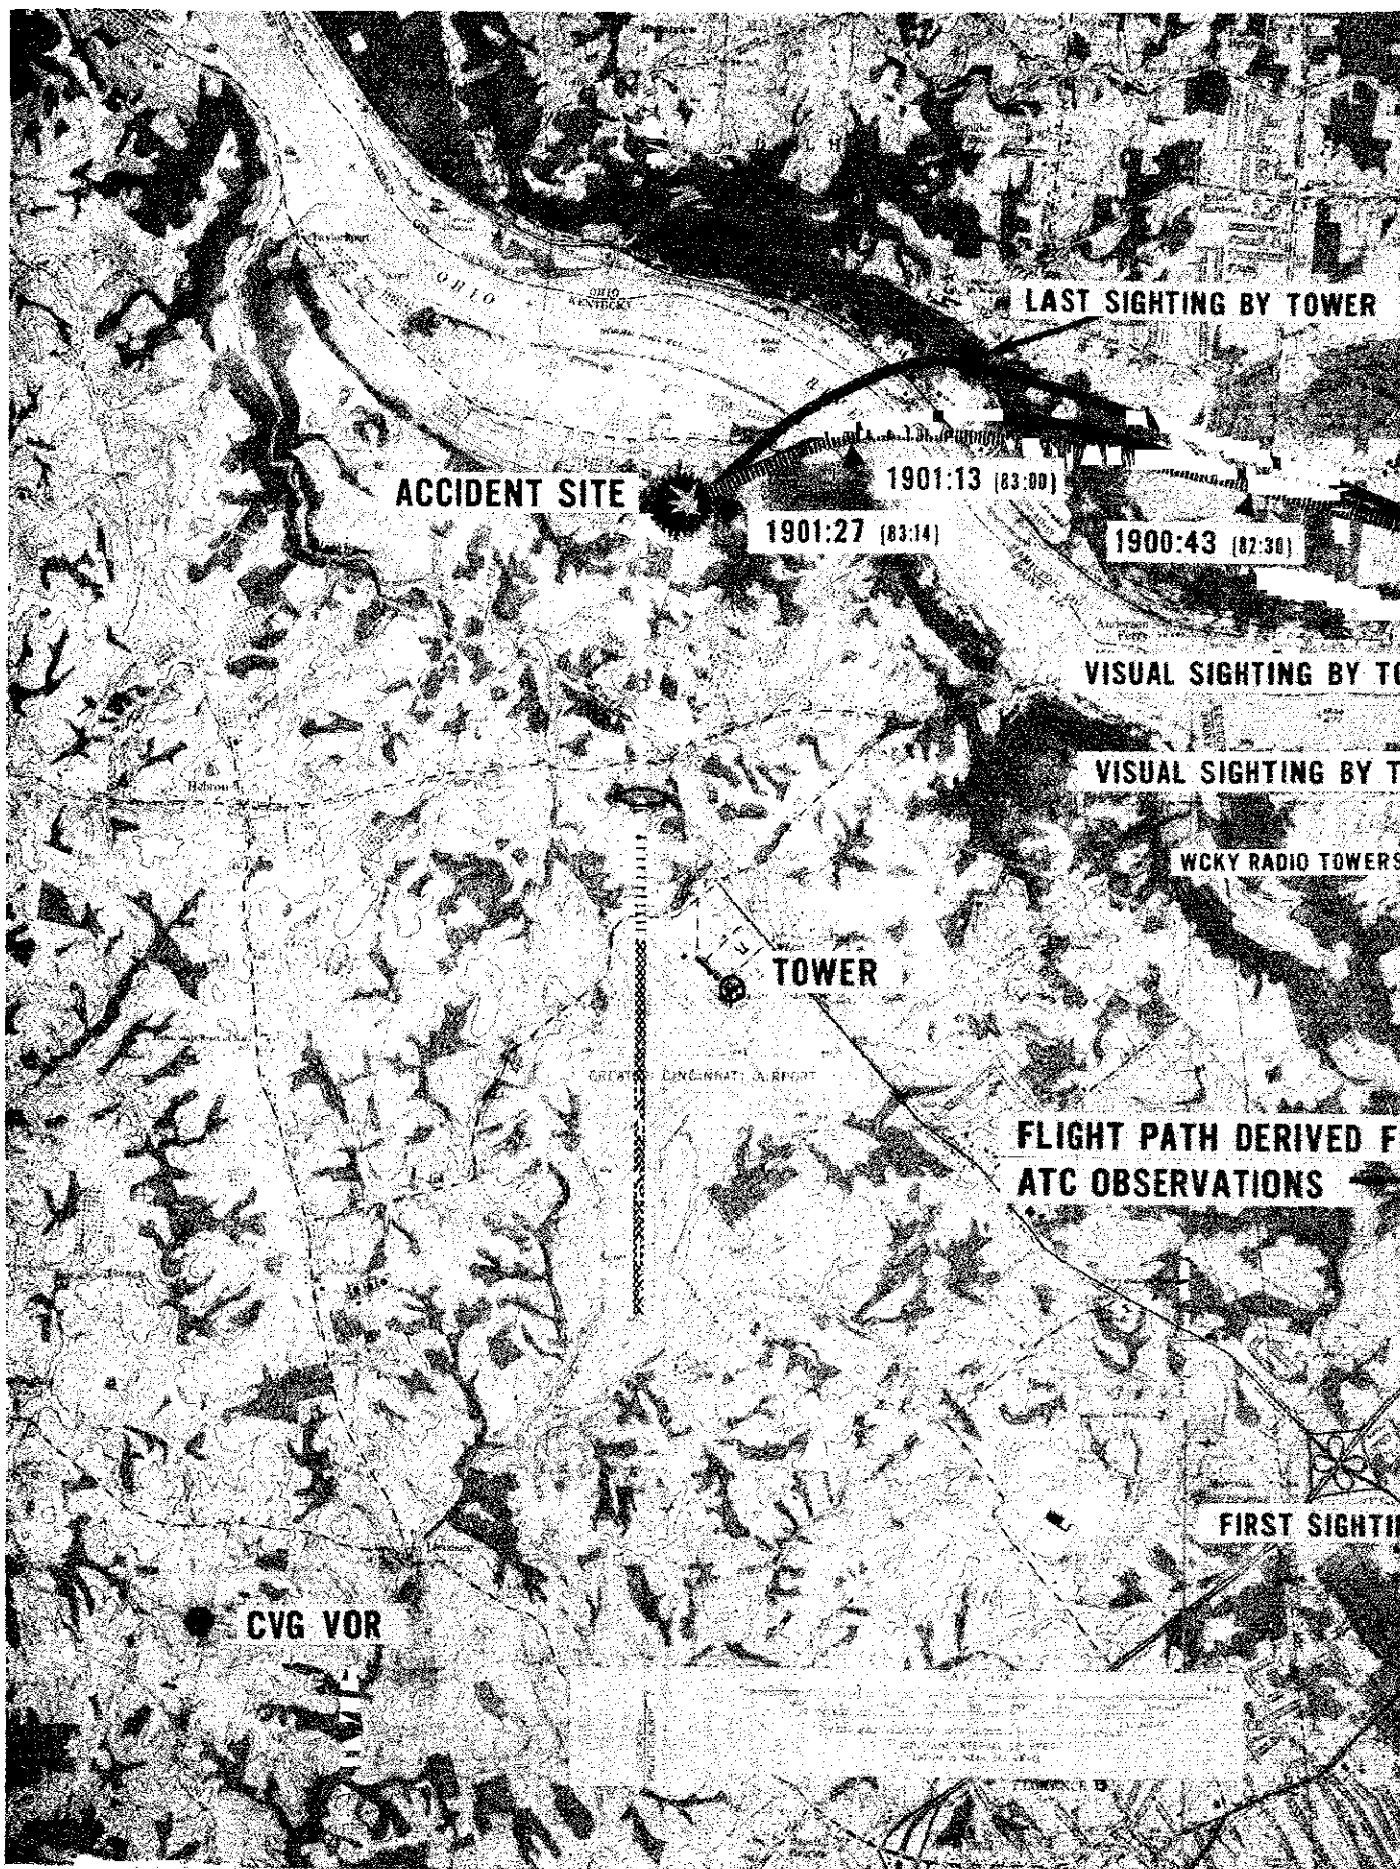
Federal Aviation Agency (FAA) tower personnel first observed the aircraft at a point approximately four miles east-southeast of the airport as it proceeded on the downwind leg in a northerly direction. (See Attachment #1.) It was stated that the aircraft's navigation lights were clearly visible and that the flight appeared to be operating at a normal traffic pattern altitude. One of the controllers stated that the aircraft passed about one mile to the east of the WCKY radio towers (located three miles east-northeast of the control tower), then commenced a left turn onto the base leg and started a gradual descent. The controller continued to watch the aircraft as it proceeded west on the base leg; however, at a point between two and three miles northeast of the airport it disappeared from his view. He stated that he believed the aircraft was lost from his view because it, "... appeared to fly into or behind weather phenomena."

A number of persons on the ground observed the aircraft during its approach. Their observations placed the aircraft approximately four miles east of the field on a northerly course while on the downwind leg. (See Attachment #1.) The flight was observed as it crossed the Ohio River and turned left to a westerly course. Witnesses stated that the aircraft had its navigation and landing lights on and that its altitude appeared to be low at this point.

It is noted that the particular terrain (see Attachment #1) in the vicinity of the aircraft's flightpath may well have provided the crew with an illusion of proper altitude or adequate terrain clearance. The Ohio River basin directly to the left of the flightpath is approximately 400 feet lower than the terrain directly under or to the right of the aircraft's flightpath. Also the terrain south of the river in the direction of the airport is featured by a wooded unlighted hillside which rises steeply from the river to the approximate elevation of the airport. Except for the lights of residences located near the riverbank there are no lights which would provide terrain definition. At night under poor visibility conditions it is quite conceivable that the elevation of the lights in the river valley could be associated with the elevation of the terrain in the vicinity of the airport.

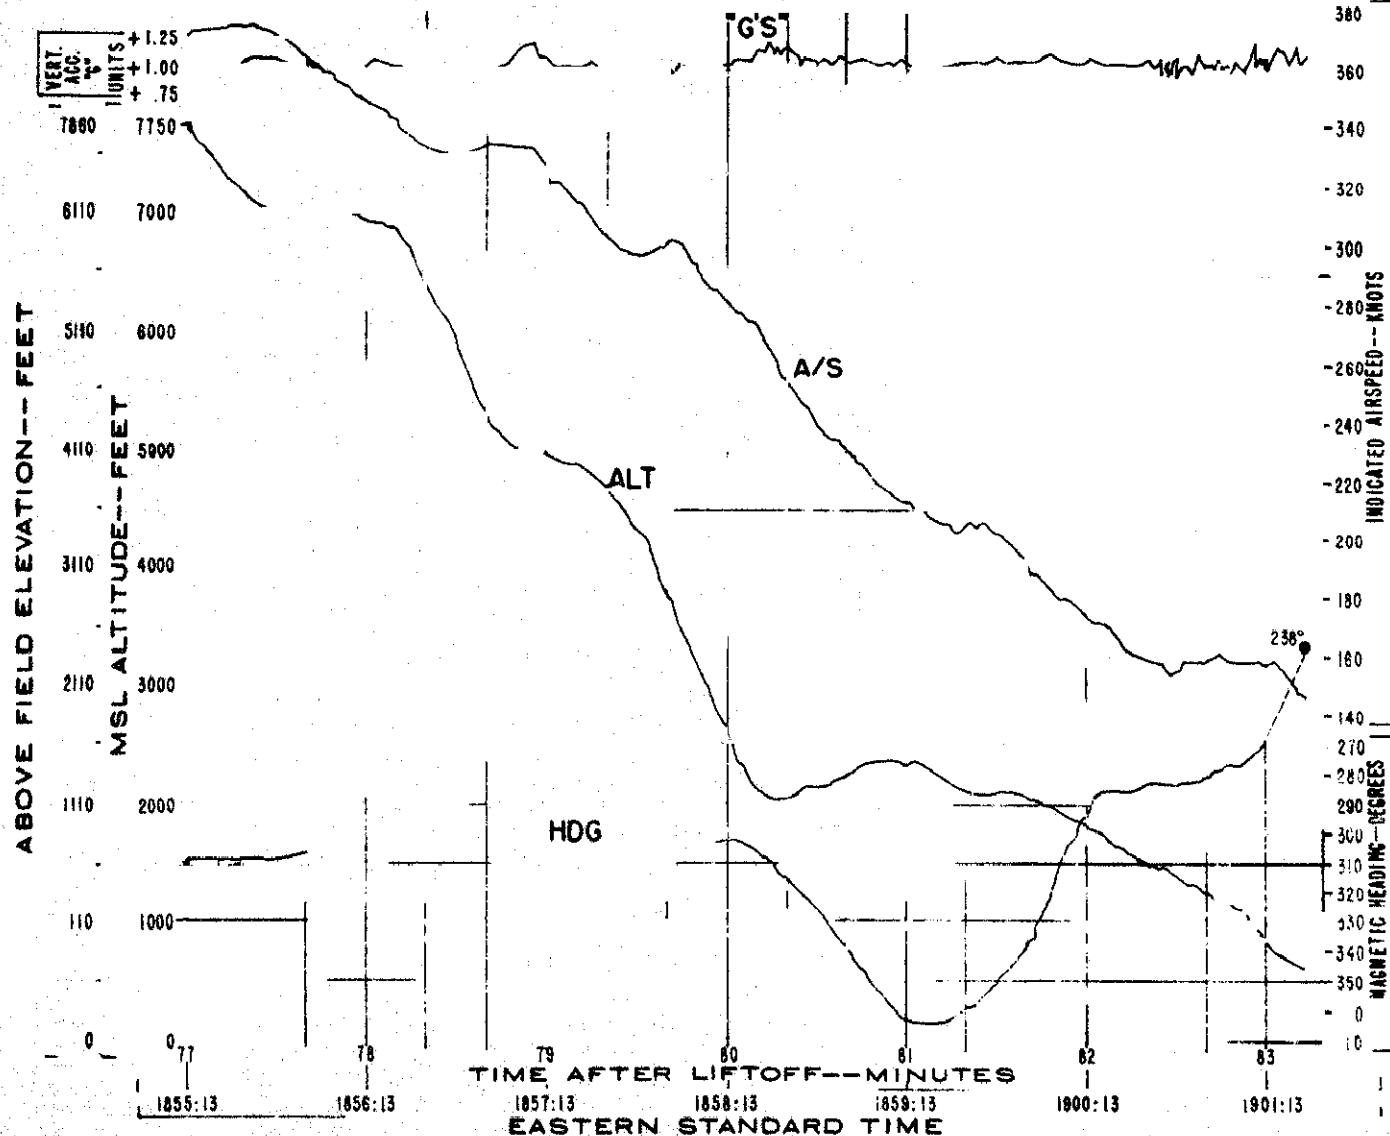
ATTACHMENT 2

The acceleration excursions noted throughout the readout were consistent with the maneuvers being performed and, except for the last 50 seconds of flight, no significant turbulence activity was noted. During the last 50 seconds of flight the G trace activity was suggestive of light turbulence computed to be less than 14 feet per second.

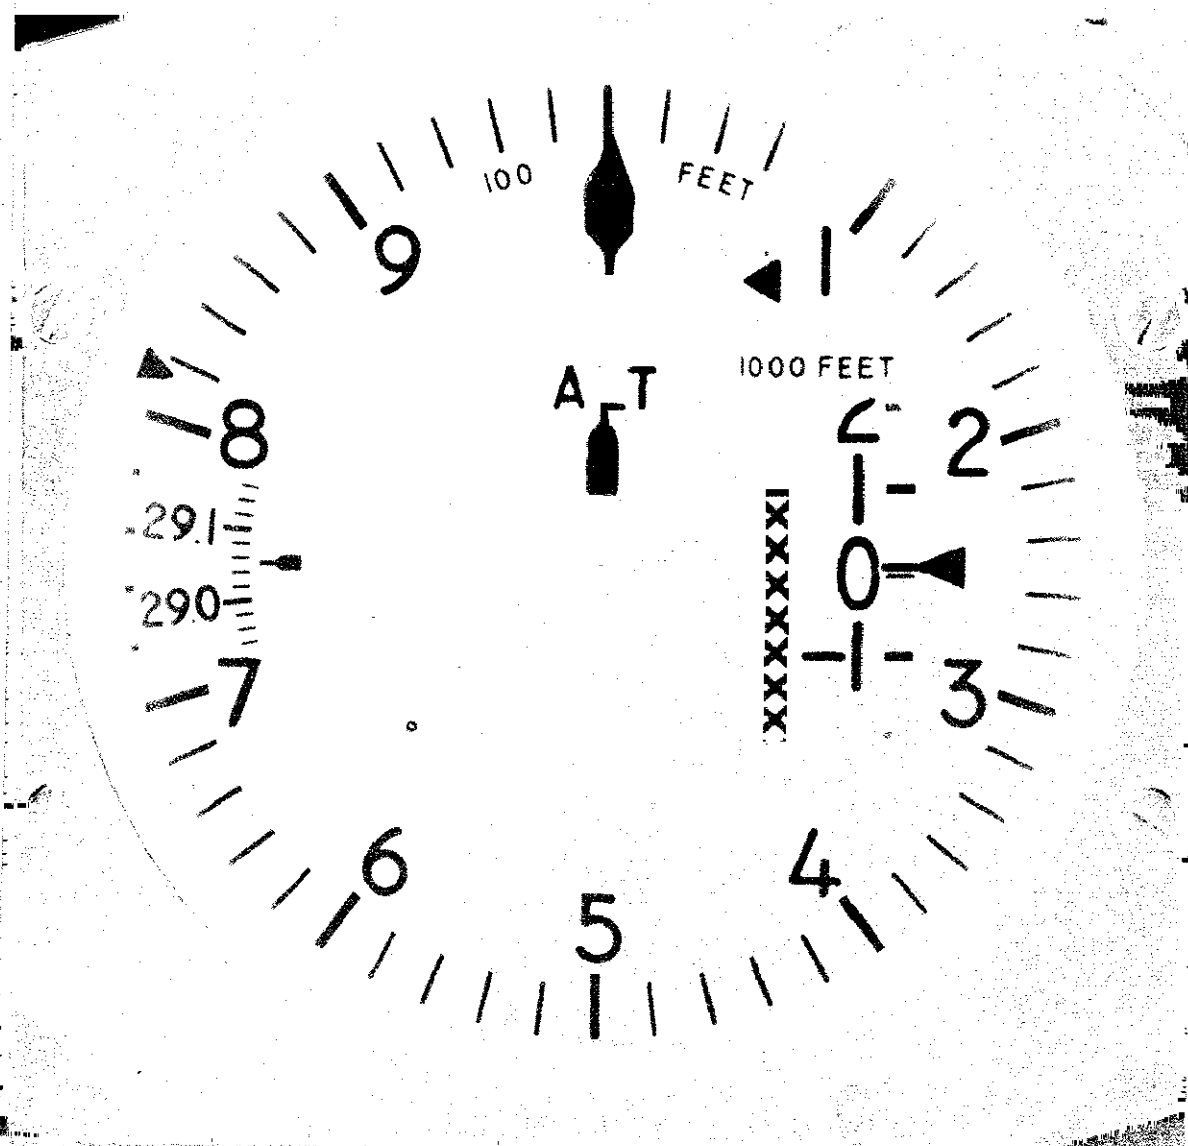
**KOLLSMAN ALTIMETER**

The three Kollsman altimeters<sup>9/</sup> installed in the aircraft were recovered from the wreckage and were examined at the manufacturer's facility. The captain's (No. 1) altimeter was found at a barometric setting of 29.06 inches with the index marker set on 800 feet. A valid drum position could not be obtained because of internal mechanism disruption. The copilot's (No. 2) altimeter was found at a barometric scale setting of 29.03 inches with the index marker positioned at 815 feet. Only portions of the center instrument panel (No. 3) altimeter were recovered and no barometric, index marker, or drum position information could be obtained. A discussion of the American Airlines procedures for altimeter utilization and related procedures will be found in section 1.15 under the heading of AA altimeter procedures.

Examination of the pilot's and copilot's altimeters revealed no evidence of any pre-impact failure or malfunction and both were set properly to indicate altitude above field elevation. The functional capabilities of the No. 3 altimeter could not be determined because of extensive impact damage to this instrument. However, based on the fact that the last ATC clearance altitude of 2,000 feet m.s.l. was maintained for approximately two minutes on the downwind leg prior to the initiation of the descent, it is believed that this altimeter was properly set and functioning normally throughout the approach.

It is realized that in these cases or in any altitude presentation a pilot knowledgeable in the altimeter should have no problem whatsoever in quickly determining the correct altitude reading. However, it can also be seen that under certain conditions compounded by infrequent, fragmented, or distracted monitoring, a misreading/misinterpretation of altitude could occur.

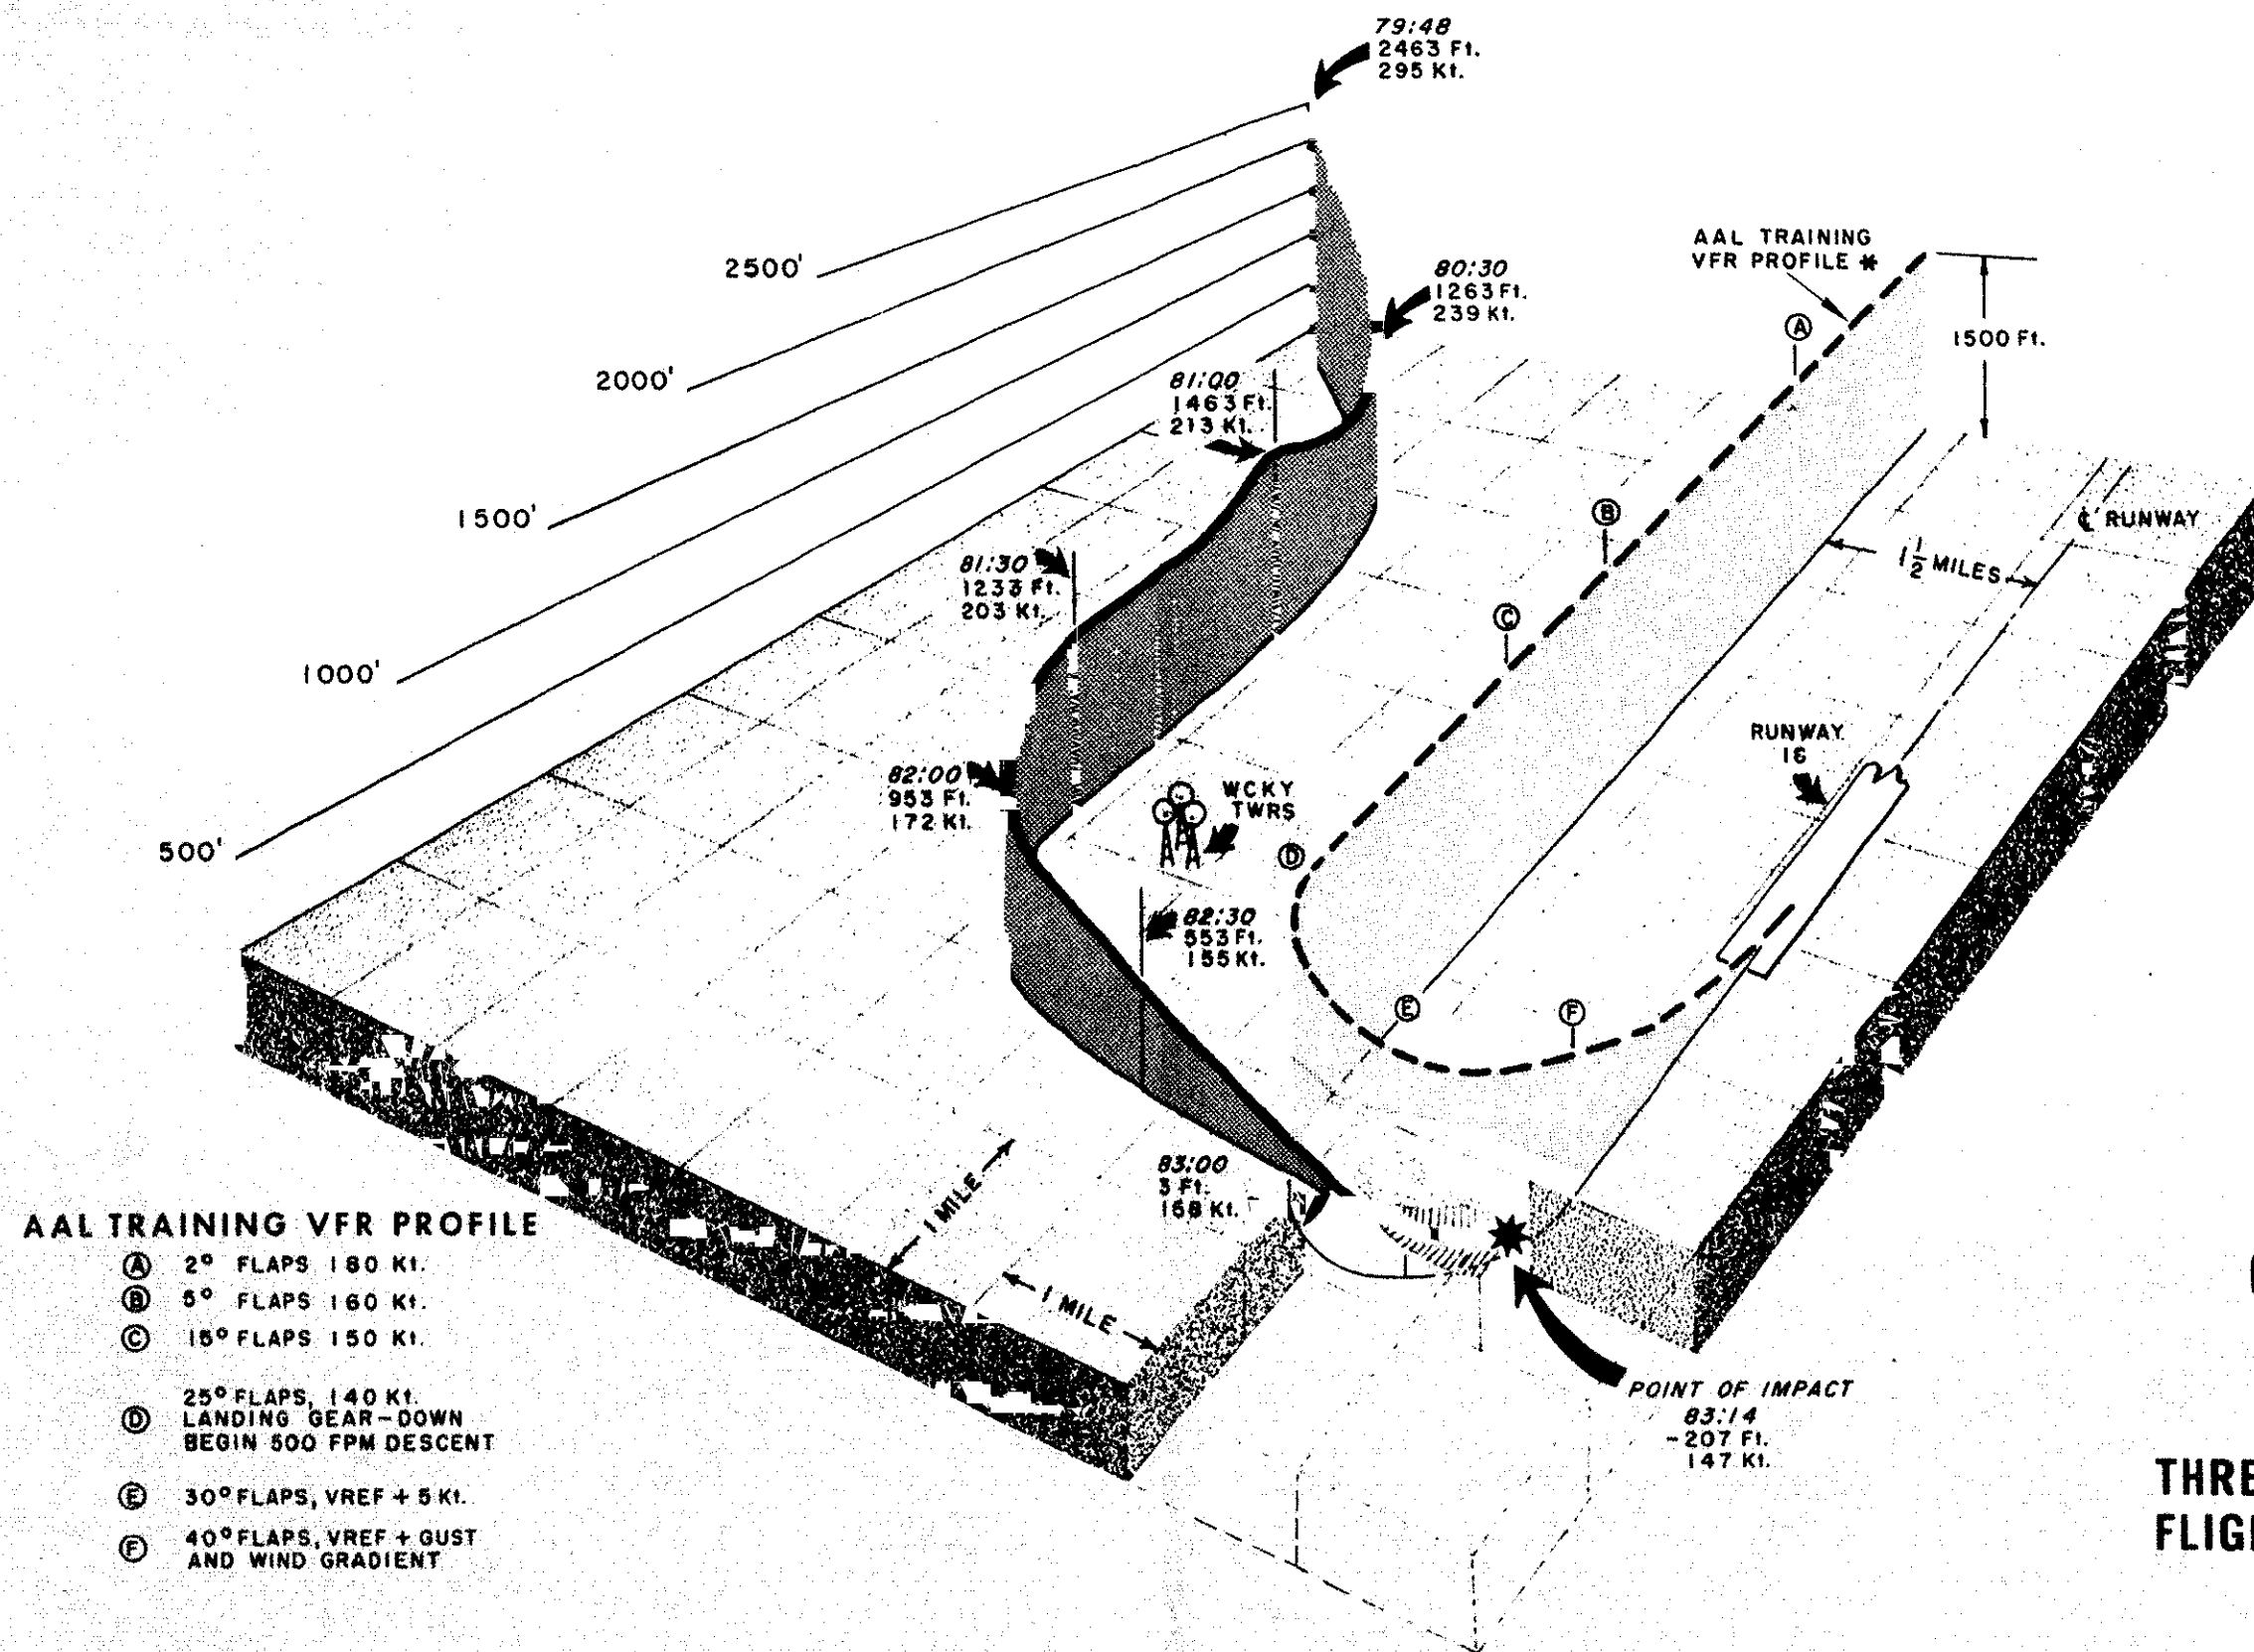
Examination of the AA 727 flight training curriculum disclosed that the normal VFR (training) pattern for Boeing 727 type aircraft (see Attachment #3) calls for the downwind leg to be flown at a distance of 1-1/2 miles out from the runway. Since the flight recorder, ATC observations, and witness observed flightpaths all indicate that the downwind leg on this flight was flown at a distance of 4-1/2 miles from runway 18, this aspect of the approach was explored in detail. Testimony from AA training and operations representatives at the public hearing indicated that although the VFR training pattern taught to pilots in the training syllabus serves as the standard or desired VFR approach, many variances of this pattern can be, and are, utilized in actual line operations. It was stated that the variables in the VFR

The traffic pattern airspeeds and aircraft configuration sequences utilized by N1996 were compared to appropriate airspeeds and recommended configuration sequences outlined in the VFR training pattern. From this study it was indicated that the various flap extensions during the approach conformed with the AA normal operating extension speeds. However, because of the comparatively higher airspeeds maintained by the flight throughout the approach, these flap extensions were concentrated or "bunched-up" on the base leg.
